Historic Structures Report
Renwick Courthouse, Wallace Library, and Old Jail
City of Fredericksburg, Virginia

Created / Last Revised:
19 April 2016/ 15 June 2016

Prepared by:
Bryan Clark Green, Ph.D.
Commonwealth Architects
101 Shockoe Slip, Third Floor
Richmond, Virginia 23219

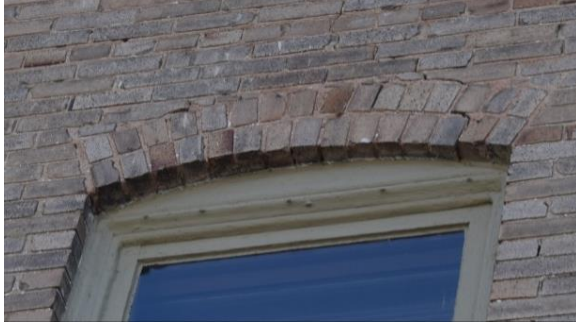
At the window openings on the east façade, open joints were observed at several of the sills. This allows water to infiltrate into the building and can cause damage to interior finishes as well as deterioration of the masonry. Several of the segmental arches above the windows show signs of displacement or cracking (Figure 4.78).

Figure 4.55: Brick displacement and joint cracks at segmental arch in east facade of Wallace Library

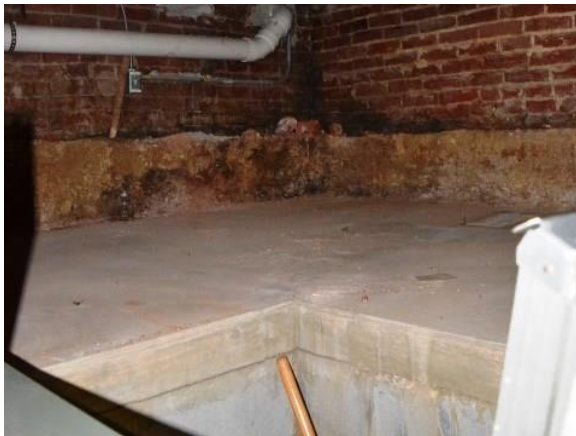
In the western half of the building, a previous underpinning effort was performed to allow for a full height mechanical space. This was done by creating 5'-0" wide concrete haunches on the west, north and south sides of the space at the interior face of the original wall footings and excavating the soil inside (Figure 4.79).

Figure 4.56: Concrete underpinning haunch in west half of basement

Rather than a direct transfer of the vertical loads from the existing footings to the underpinning, this approach relies on the haunches' ability to contain the soil below the footing bearing and resist the resulting lateral pressures.

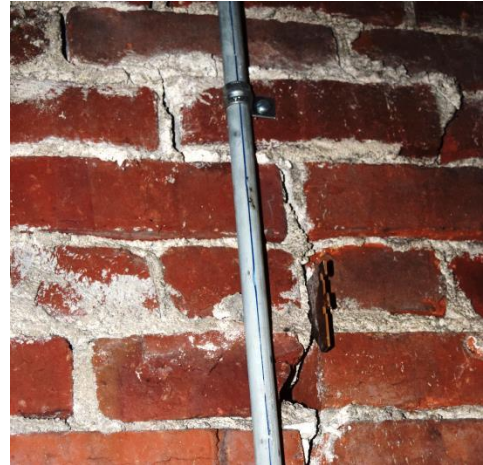
Evidence of foundation settlement along the North building wall was found in the form of significant interior cracking (Figure 4.80). This cracking in brick foundation wall matches the

location of the observed exterior crack. A shim was able to be inserted approximately 8" into the mortar joint, indicating a through-wall crack.

Figure 4.57: Through-wall crack on interior face of north foundation wall. Note shim inserted in crack.

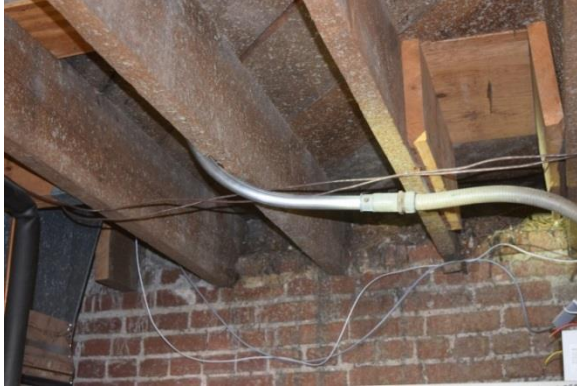
Figure 4.58: First floor framing at west end of mechanical room. Note evidence of mold.

Joist bearing ends are in fair condition with localized evidence of deterioration and softness at the west wall. Mold, likely due to moisture from the mechanical equipment, is typically present on joists ends, extending up to 3 feet from the exterior wall.

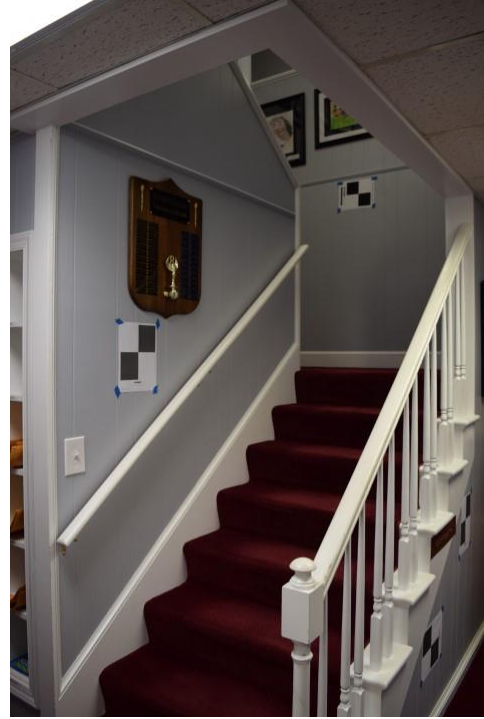
Figure 4.59: Central stair case leading to second floor

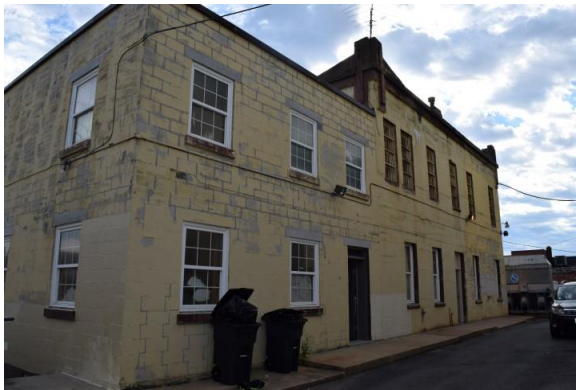
Figure 4.60: West façade of the Old Jail

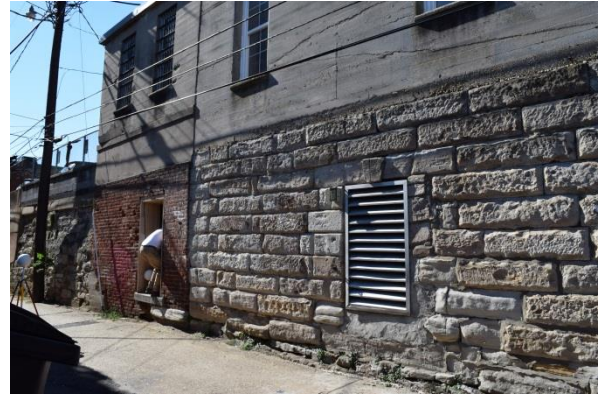
Figure 4.61: Historic brick and ashlar stone masonry foundation walls below more recent cast-in-place concrete structure above

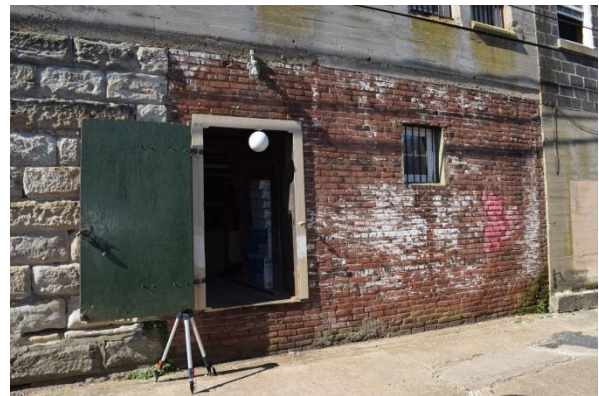
Figure 4.62: Historic brick and ashlar stone masonry foundation walls at southern and central portions and cast-in-place foundation wall at northern portion of jail

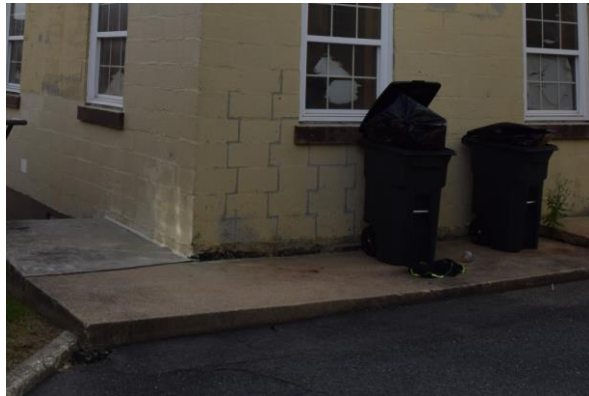
Settlement of the concrete sidewalk at the northwest corner of the building is evident (Figure 4.50). A ghost line of its original elevation can be seen on the adjacent CMU wall. A tripping hazard now exists between the corner sidewalk section and the adjacent portion of sidewalk.

Figure 4.63: Settlement of the concrete sidewalk at northwest corner. Note also the previous repointing efforts in CMU walls.

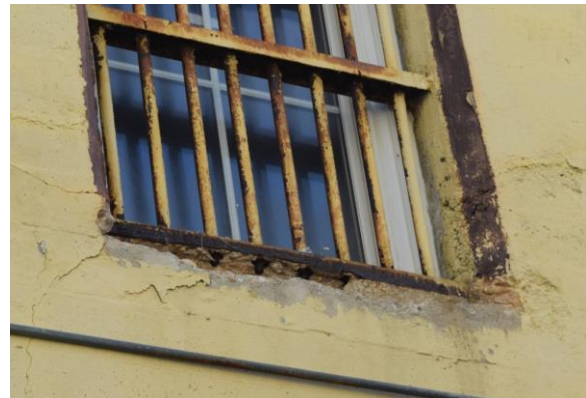
In the cast-in-place concrete portions of the superstructure, window and door openings have concrete lintels integral with the reinforced concrete walls. Concrete window sills are still visible at many of the first windows; however, they have fallen off at many others (Figure 4.51). This is due to the embedded bars from the window protection system corroding, expanding and exerting pressure on the surrounding concrete. Spalled and cracked concrete around the windows at the jambs is also evident at some locations (Figure 4.52), also due to corroding bar anchorage elements.

Figure 4.64: Spalled concrete and missing sill at second floor window opening on west façade

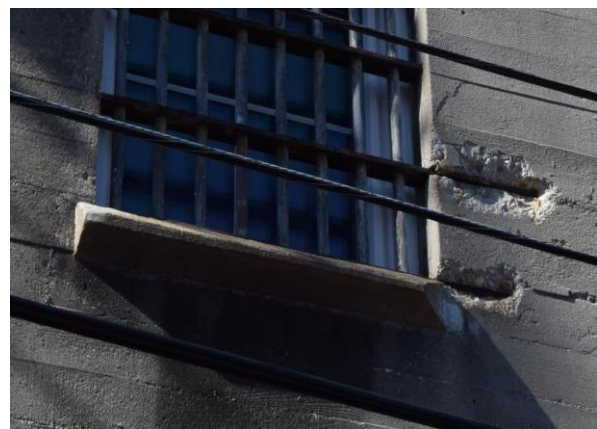
Figure 4.65: Spalled concrete around window openings at corroded bar system anchorages (east façade, 1-story extension)

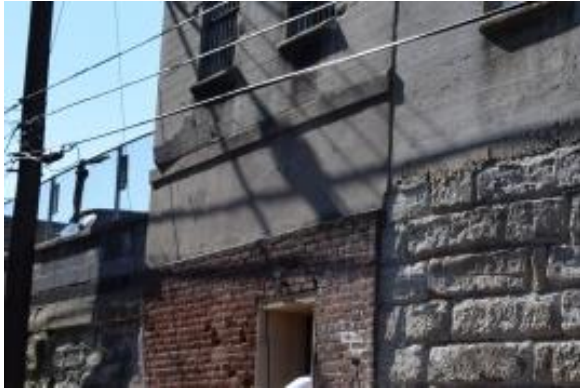
At the southern one-story extension, the transition of the earlier brick foundation wall to the cast-in-place vertical addition wall differs from the detailing at the central portion of the building (Figure 4.53). A stem wall appears to have been built with the first floor slab edge placed on top and visible from the exterior. The remainder of the wall was then poured above the slab with a perimeter steel element at the juncture to provide a positive connection.

Figure 4.66: Southern section first floor slab edge visible from exterior

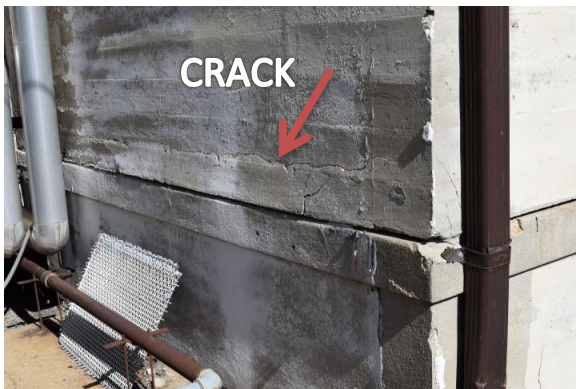
Water has found its way into the joint, resulting in corrosion, delamination and expansion of the steel elements. As a result, the concrete has cracked and spalled at various locations around the perimeter. On the west facade of the addition, a crack in the concrete follows the joint approximately 6" above the top of the slab and the concrete appears to be on the brink of spalling off (Figure 4.54).

Figure 4.67: One-story extension with cracking and spalling concrete above the first floor slab edge

Old Jail	
Recommendation	Priority (1, 2, 3, or 4)
<i>Priority 1</i>	
Remove loose and spalling concrete around windows in cast-in-place concrete portion of the building to prevent concrete falling and potentially harming pedestrians.	1
Remove loose and spalling concrete at one-story south extension above first floor slab to prevent concrete falling and potentially harming pedestrians.	1
<i>Priority 2</i>	
At northwest corner of building, remove settled concrete slab. Compact soil below and fill with crushed stone as required. Pour new section of slab on grade to be level with adjacent sections.	2
At windows in cast-in-place concrete portion of building, clean corroding bars and anchorages at windows. Coat with rust inhibiting paint, apply bonding agent, and patch concrete with trowel-on patching mortar	2
At one-story south extension above first floor slab, contract licensed structural engineer to perform probe investigation and determine construction of joint and function of embedded steel perimeter elements. Repairs to be determined per investigation.	2

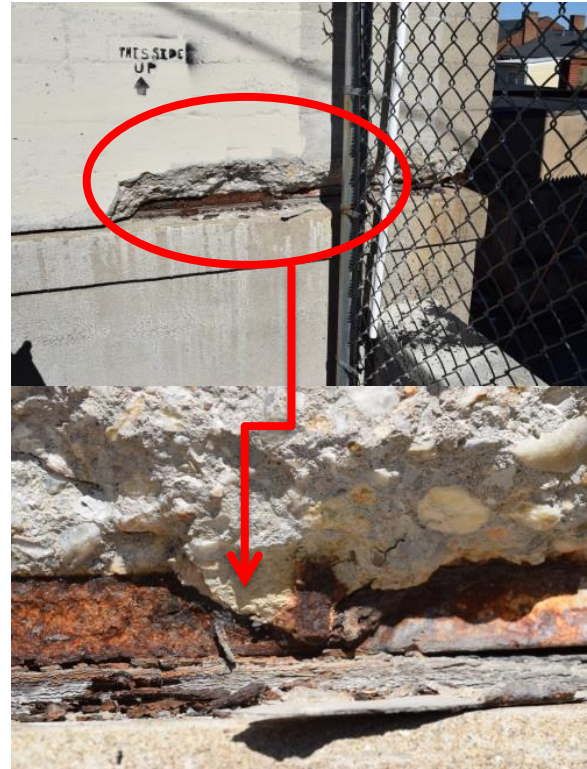
The worst condition exists at the southeast corner of the building, where the concrete has spalled off completely, exposing the corroded steel elements within. It is possible that the anchorage of the walls above to the floor slab is compromised due to this condition.

Figure 4.68: Spalling concrete and delaminated steel at southeast corner of jail

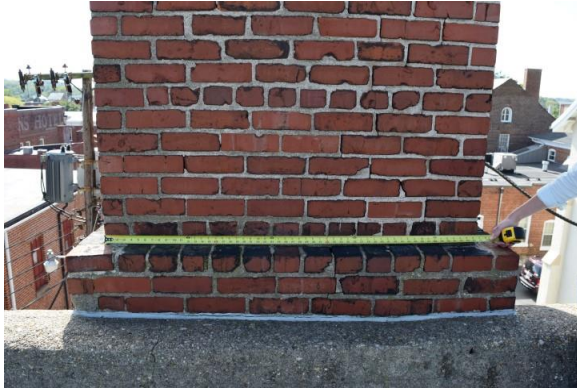
The center cast-in-place concrete building is approximately 8 feet taller than the northern CMU addition. The higher roof is surrounded by a 14-inch thick exposed concrete parapet extending approximately 2 feet above the nearly flat roof. In general, the parapet appeared to be in good condition, although small cracks were visible at discrete locations. At the south end of the center building, a large, brick chimney extends nearly 12-feet above the roof line. This chimney measures approximately 40-inches deep by 54-inches wide. Chimneys are particularly susceptible to degradation of the mortar joints due to their high exposure to the elements. The chimney appears to have had previous repointing efforts performed; however, it is currently exhibiting more recent cracking and open joints (Figure 4.55). This decreases its resistance to wind and seismic (lateral) loads.

Figure 4.69: Brick chimney at south end of center building section

Repoint open joints and cracks in chimney. Use mortar matching existing in color and composition.	2
At bulging stone retaining wall at southeast corner, contract licensed structural engineer to determine construction of wall and perform structural analysis. Structural repair scope could consist of disassembling and rebuilding wall with improved drainage or installing walers with anchors into soil behind wall.	2
Where east brick and stone foundation walls have experienced mortar loss and/or brick loss, perform deep repointing of walls using mortar matching existing in color and composition. Replace missing bricks in kind.	2
In basement of central portion of building, where no lintel exists above opening in brick partition, provide new steel angle lintels (one per wythe of brick).	2
In basement of one-story southern extension, remove all wet and moldy boxes of papers and other stored items.	2
In basement of northern CMU portion of building, infill all abandoned MEP openings in southern brick wall. Perform masonry repairs along the diagonal crack with compatible mortar. Monitor repair for any signs of new movement or crack formation.	2

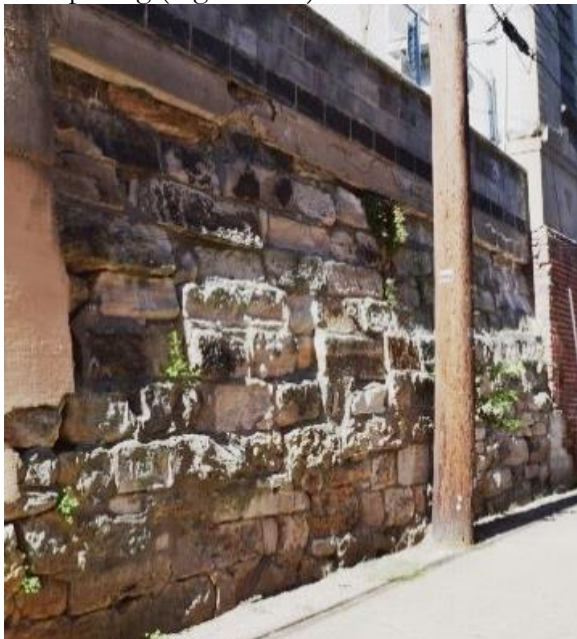
A stone retaining wall extends south from the southeast corner of the building and supports the parking lot above. It shows obvious signs of bowing out around 1/3 to mid-height (Figure 4.56) and is now nearly a half foot out of plumb. Vegetation is growing through the open joints between stones and lichen growth can be seen on the stones, indicating high levels of moisture in the wall. Previous repointing efforts were made to attempt to infill some of the open mortar joints. A concrete member caps the stone portion of the wall at the parking lot level and is cracking and spalling (Figure 4.57).

Figure 4.70: Bulging retaining wall in line with rear foundation wall of jail

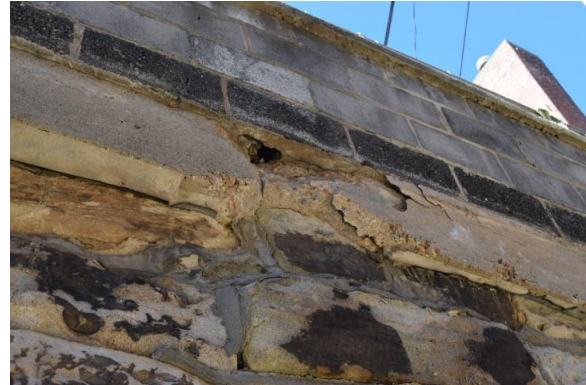
Figure 4.71: Cracked and spalling concrete at southeast retaining wall below parking lot

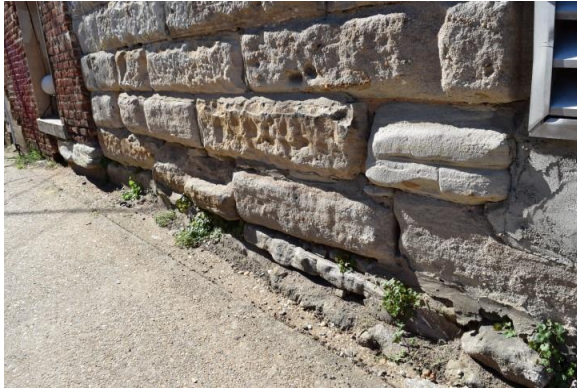
As noted above, the foundation walls as seen from the alley to the east of the Jail vary in materials and construction periods. Ashlar stone, brick, and cast-in-place concrete walls are all visible and are in varying conditions. The stone wall below the central portion of the jail appears to be the earliest construction and shows signs of wear of the stone units themselves, likely due to their age and exposure to the elements (Figure 4.58). There is also significant mortar loss in the joints. A louver was installed at a location where there was likely a window opening previously; however, the opening had to be enlarged and the stone work around the opening was performed rather carelessly. Stones below the opening were removed and the remaining space grouted.

Figure 4.72: Early stone foundation wall under central portion of jail building. Note corner of louver on right.

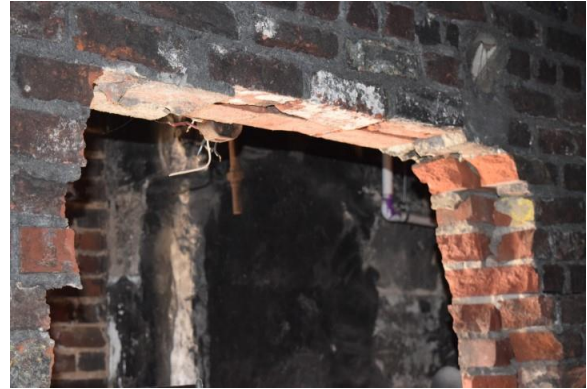
At the interior of the early stone portion of the building, a two wythe brick partition exists in the east of the basement. This wall has no contact with the framing above and is therefore not carrying any floor loading, but it has large openings without lintels to support the masonry above (Figure 4.59). A cast-in-place concrete tunnel extends from the west wall of this space, presumably to the courthouse to the west.

Figure 4.73: Unsupported masonry in center basement

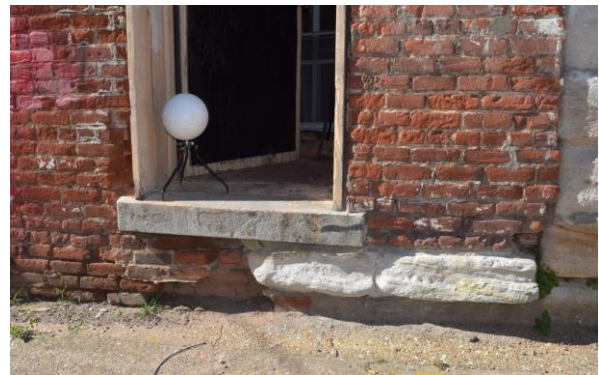
At the one story addition to the south of the jail, there is significant brick loss below the door threshold at the entrance to the basement (Figure 4.60). Above the doorway, there is no lintel to support the brick and the door frame appears to be doing this work. Significant mortar loss exists above the opening at the interior and exterior faces.

Figure 4.74: Loss of brick under threshold in foundation wall below 1-story extension

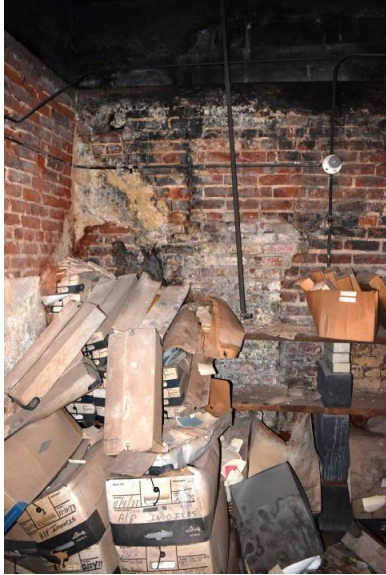
Presumably used historically as a boiler room, a coal chute is still visible at the interior. The room is presently being used for storage of papers, which are now saturated and moldy (Figure 4.61). This continually wet environment is contributing to the long-term degradation of the mortar and brick in the walls.

Figure 4.75: Brick foundation walls of old boiler room. Note current paper storage and moisture.

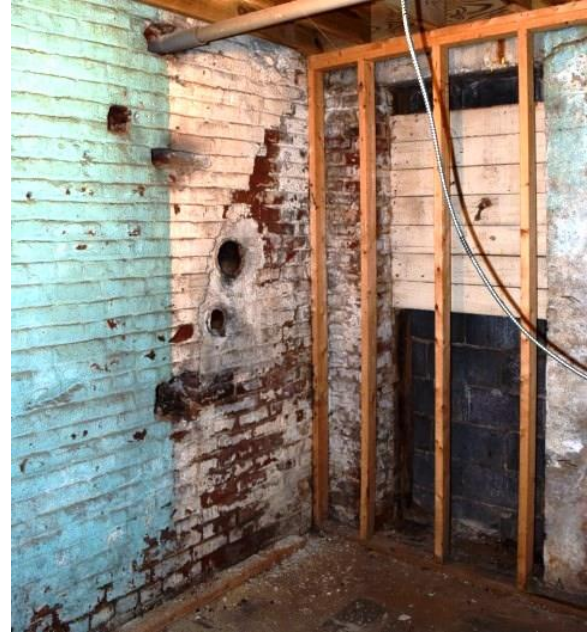
In the southwestern corner of the north addition basement, a previous wall opening exists (Figure 4.62). As the space on the other side of this opening is below grade, it is assumed that there was a functioning tunnel at some point in time. The lintel above this doorway shows signs of failure; however, since the opening is now infilled with CMU, the lintel is no longer being asked to carry the loads it once was and this is no longer a structural concern.

Figure 4.76: Brick foundation wall penetrations of northern jail addition. Note previous entrance to presumed tunnel with lintel distress.

On the southern side of this corner, the brick foundation wall contains abandoned MEP penetrations that are in need of infill repair. At this location, diagonal cracking is also evident, possibly caused by the combination of in-plane shear loading due to soil pressures from the west and the presence of these wall penetrations. Abandoned and/or improperly created openings in walls were also observed in other locations within the jail basement areas.

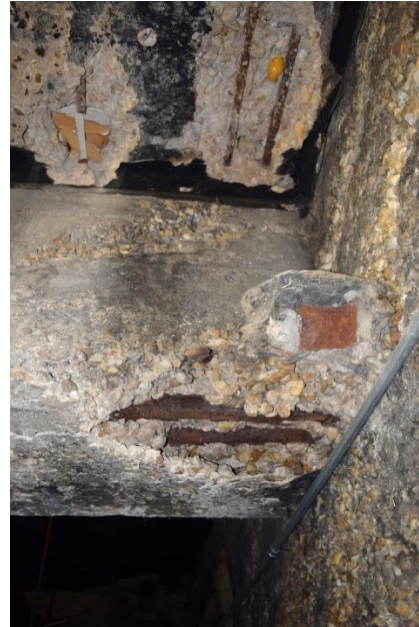
The first floor framing for the central portion of the jail house is a system of reinforced concrete beams supporting a 6" one-way reinforced concrete slab. At many locations, concrete has spalled and reinforcement of the structural elements is visible. This is likely due to a combination of high moisture, inadequate concrete cover for the reinforcement, and the resulting corrosion of the reinforcement. At some locations, the quality of the concrete mix is poor, with a high aggregate to cement ratio and relatively large aggregate size. In

concert with inadequate vibration during construction, this caused the concrete to honeycomb. Deterioration is typically the worst on the west side of the building where moisture is likely to collect in the soil below the pavement at the first floor level. The slab reinforcement at one location was observed to consist of square bars spanning between the beams at approximately 8" on center. Temperature and shrinkage reinforcement in the perpendicular direction was also observed. First floor framing beams span east-west between perimeter masonry walls and vary in size and spacing. Summarized below are the conditions of the first floor framing beams, from south to north:

- Beam 1 (southernmost beam): located approximately 9ft from the face of the southern wall, 18" wide by 22" deep. Deteriorated west end of beam with the bottom bars exposed and measuring 1-3/8" diameter at approximately 4" on center. 3" side cover and 2" bottom cover (Figure 4.63).
- Beam 2: located approximately 10 feet to the north of Beam 1, 17.5" wide by 21" deep. No significant deterioration observed.
- Beams 3 and 4 are adjacent to each other just to the south of the tunnel entrance. Both beams measure 18" wide by 21" deep. (Figure 4.64)

Figure 4.77: Beam 1 and exposed reinforcing

At first floor concrete beams and slabs, where reinforcement has corroded and concrete has spalled, clean reinforcement, paint reinforcement with rust inhibitor, apply bonding agent and repair concrete with trowel-on patching mortar.	2
At northern CMU addition, install mid-span bridging between joists at first floor, second floor, and roof framing.	2

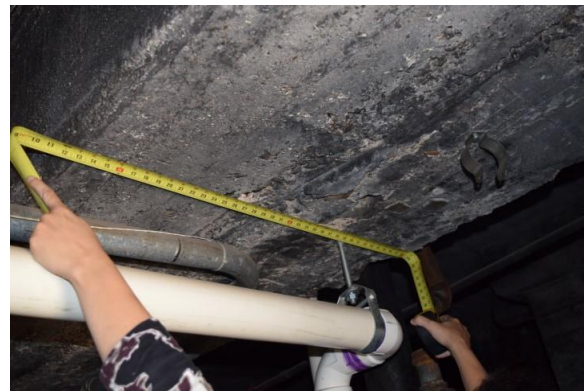
Figure 4.78: Double beams 3 & 4

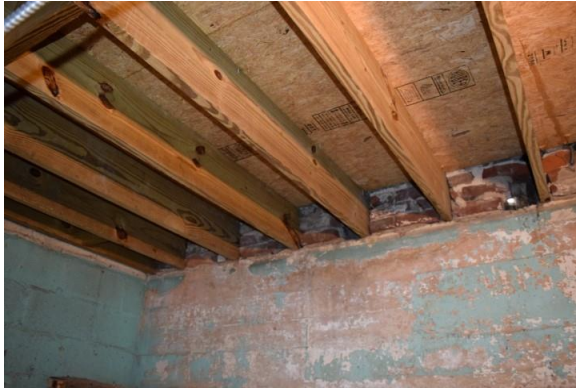
Figure 4.79: Northern addition first floor joists bearing on perimeter concrete wall

In the later, northern addition, the floor framing system has recently been replaced with 2x10 wood joists spaced at 16-inches on center. The joists span east to west between perimeter concrete walls and an interior CMU bearing wall and currently support plywood sheathing. The joists bear on a ledge in the exterior concrete load bearing walls and are packed with brick to prevent rotation (Figure 4.65). No bridging was observed between joists.

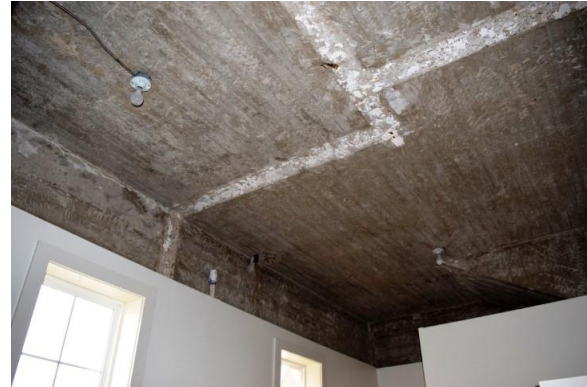
There is evidence of removed interior walls (Figure 4.66). It is currently unknown if the removed walls were bearing walls supporting the slab above, and it is possible that the slab in its current configuration is inadequate to support the design loads. However, loading on the second floor slab is currently significantly reduced since the space is

unoccupied and there are no visible signs of distress.

Figure 4.80: Location of removed concrete wall in cast-in-place concrete jail house

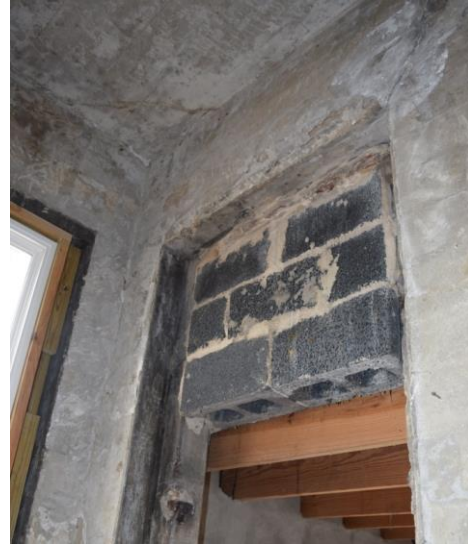
At the junction between the concrete structure and the CMU northern addition, a small doorway exists, likely originally a window. Due to the difference in elevation between the roof levels in the two buildings, the top of the opening was infilled with CMU. However, this infill is currently unsupported and appears to be held in place with only mortar (Figure 4.68).

Figure 4.82: Second floor doorway between center building and northern addition

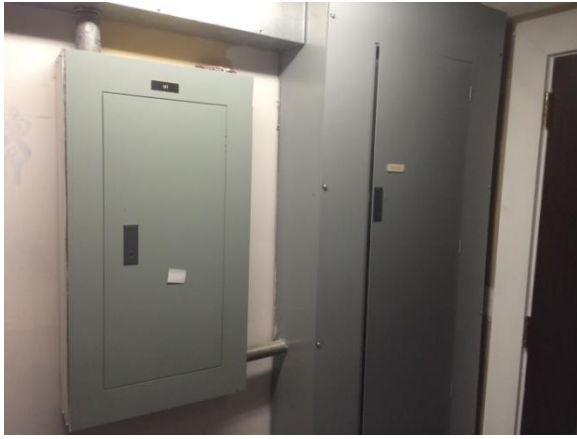
Figure 5.9: Building electrical distribution.

Lighting is T-12 magnetic ballast fluorescent lamps. We assume that all building lighting will be replaced in a renovation as the current fixtures do not meet current energy code requirements. Some, but not all, of the offices are equipped with motion sensors.

Existing lighting should be replaced with more efficient fixtures. Power to the building is adequate.

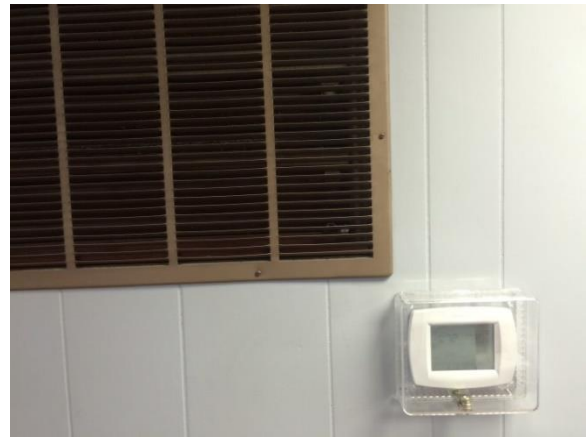
5.12: Library corridor return and thermostat.

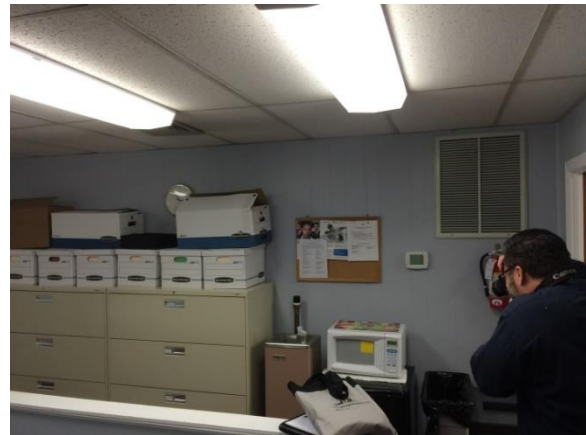
Figure 5.13: Library first floor return and thermostat.

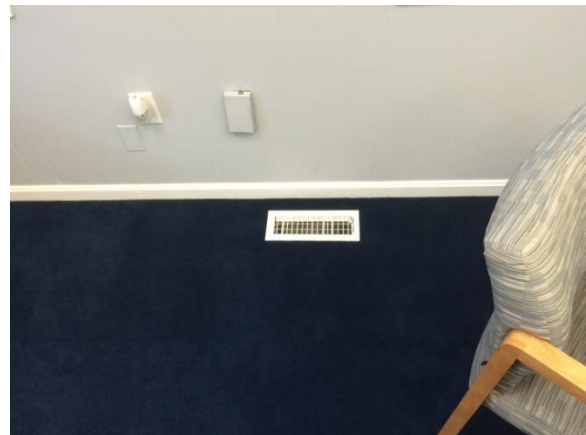
Figure 5.14: Library floor diffuser, first floor.

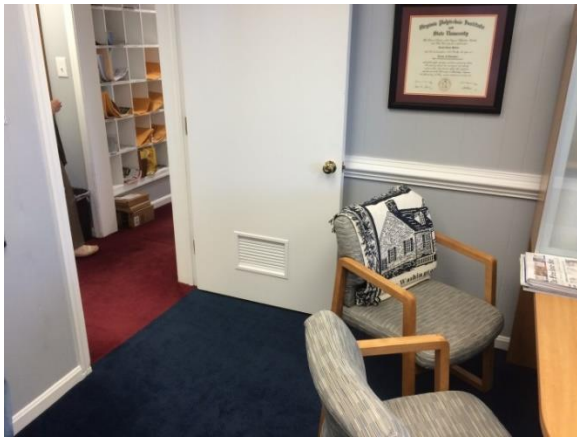
Figure 5.15: Library, return louver in door.

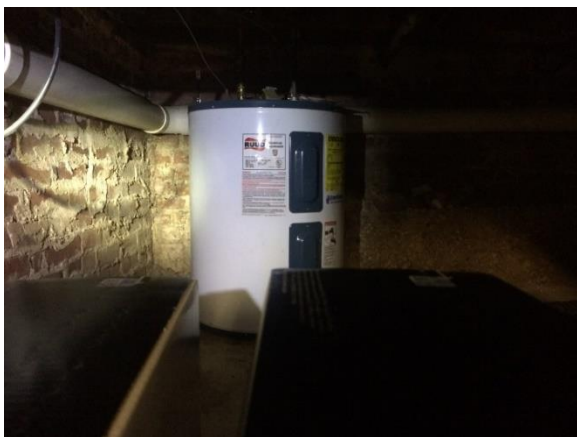
Domestic hot water is generated in a small electric heater located in the basement. There are two bathrooms upstairs along with a Janitor's Closet. Fixtures are tank top.

Figure 5.16: Library, electric water heater.

The plumbing fixtures do not meet the 1992 or 2005 Energy Policy Act water efficiency requirements. They should be replaced. The water heater should be replaced.

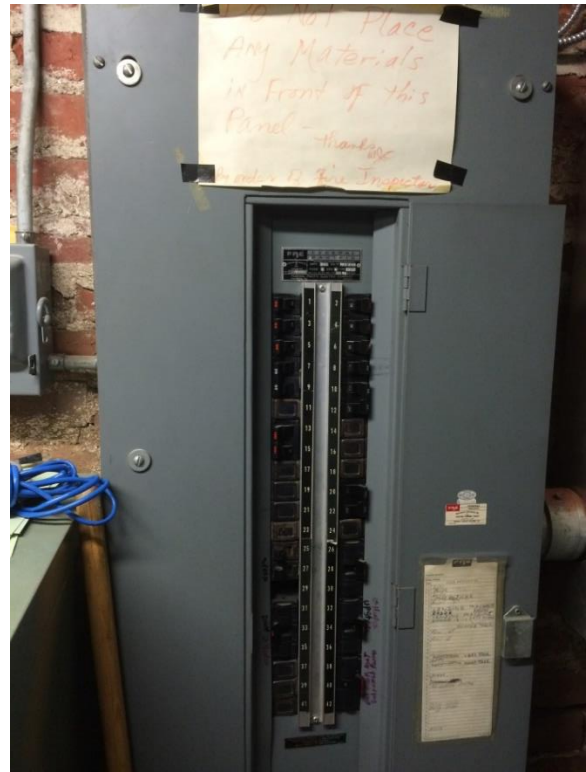
The building is served by a 300 amp, 120/208 Volt, 3 phase main panel located in the basement. There is a 240/208v transformer on the wall in the basement. We are unsure what piece of equipment this serves.

The main gear is Federal Pacific as is the breaker panel.

Figure 5.17: Library, main breaker panel.

The electrical service is dated and not in good condition. Even more troubling is the fact that the panel and breaker manufacturer, Federal Pacific, has gone out of business. This will make finding new breakers difficult. The electrical service size is marginal and we recommend that the service size be increased to 400 amps.

The main service and power distribution should be replaced. Lighting systems should also be replaced as described above.

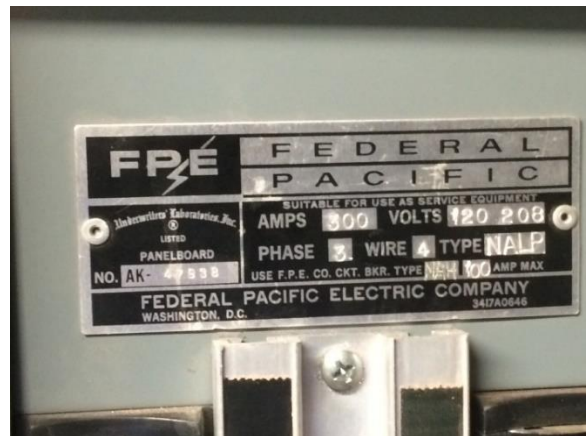
Figure 5.18: Library, main service label.

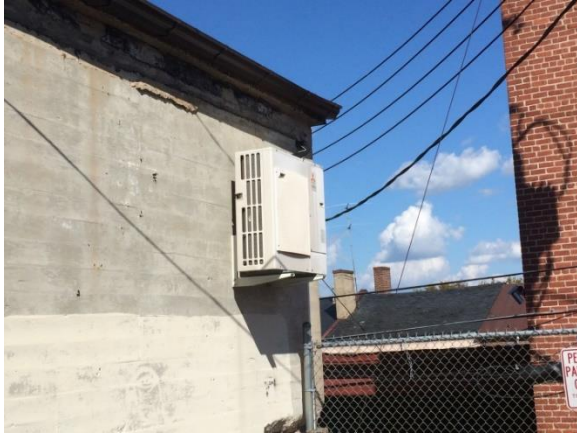
The Old Jail has a two-ton mini-split heat pump with a condensing unit on the low roof and two indoor units.

Figure 5.19: Jail, mini-split condensing unit.

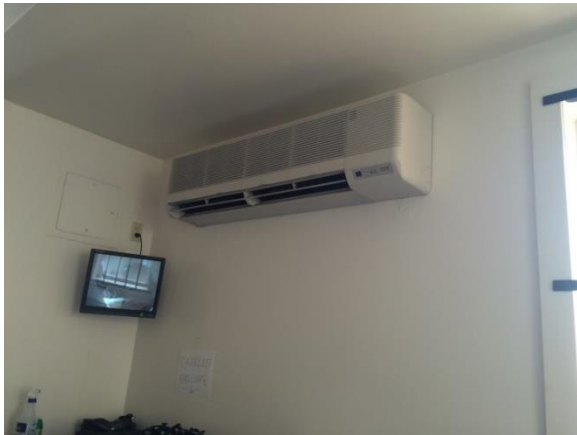
Figure 5.20: Jail, indoor unit.
